## **Barton suggested start of season deck hardware checks**

### **Checklist for blocks, sheaves, mainsheet traveller & genoa cars:**

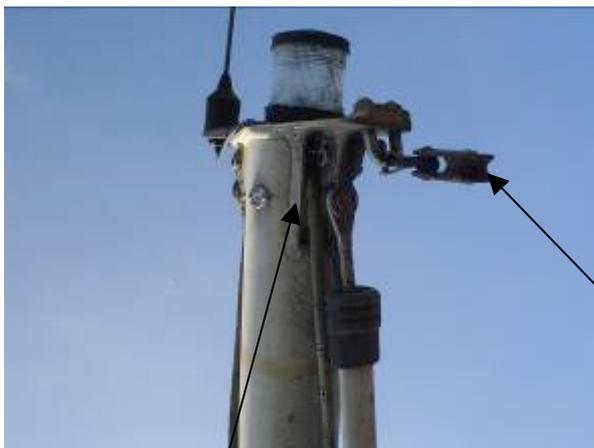
#### **This masthead definitely needs some attention**

**Remove and inspect sheave**

**Replace this block**

Check for excessive movement on the bearings of both sheaves and blocks, especially at the mast head. A broken mast sheave invites the halyard to jam itself at the worst possible moment with a trip aloft the only alternative to remove a sail. Barton carries a range of sheave sizes from 30mm up to 70mm diameter or you can contact your mast manufacturer for replacements. If you cannot get the exact same diameter, that's ok, as long as you make sure your replacement sheave is a tight fit width ways in the mast casing to prevent your mouseline jumping off the sheave and jamming.

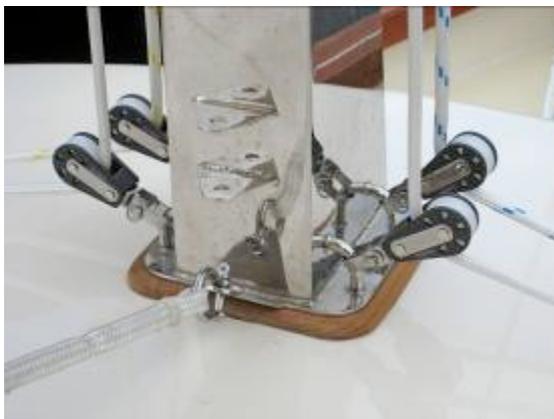
**Plain bearing blocks fitted at the mast base**

For ball bearing blocks, the sheaves should spin freely. Again, flush through with fresh water. Any grinding or uneven spin after flushing would suggest the block has been overloaded. Ball bearing blocks are not suitable for high static loads, such as round the mast base, so you should replace with a plain bearing block or one with a higher rolling load rating.

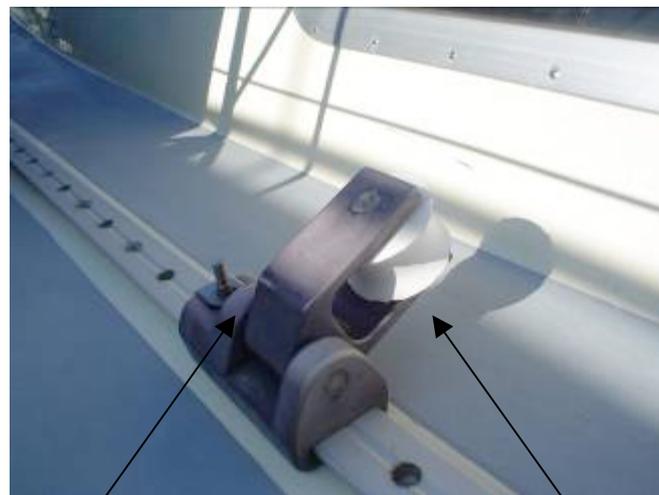
**Broken pin needs replacing**

**Sheave damage will chafe sheets**

**Genoa Cars** – Check for signs of excessive movement about the sheave bearing. A small amount of play is acceptable, but any more than this may cause the sheave to lock up under load. Warning signs include excessive wear to one side of the sheave where it is not rotating.

Sheaves can be replaced so long as the car has been regularly flushed through and looked after. Heavy corrosion of the aluminium around the spindle makes it impossible to repair, so a replacement would be essential.
